Forklift truck reverse sensor systems assessment

Prepared by the Health and Safety Executive

RR1084

Research Report

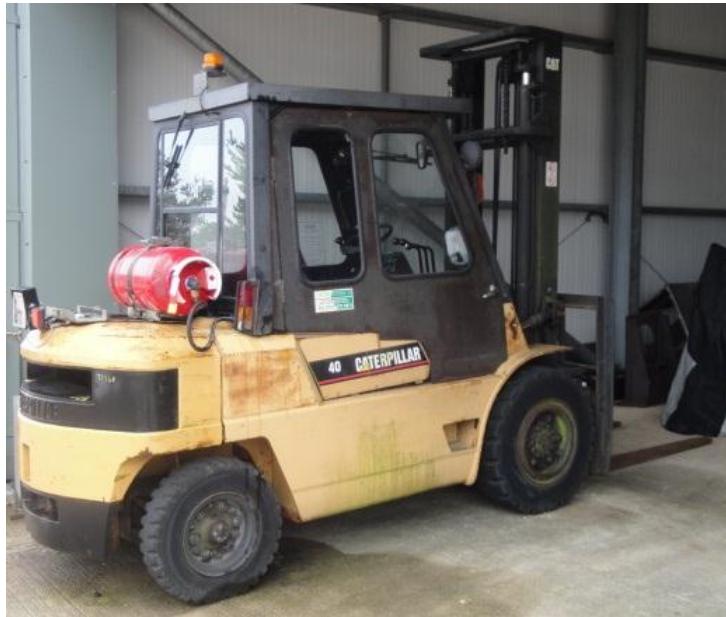
A 4 tonne Caterpillar (CAT) - 40 FLT at HSE's Buxton laboratory was selected as the test vehicle for three of the reversing sensor systems (see Figure 1).

Figure 1 CAT-40 test vehicle

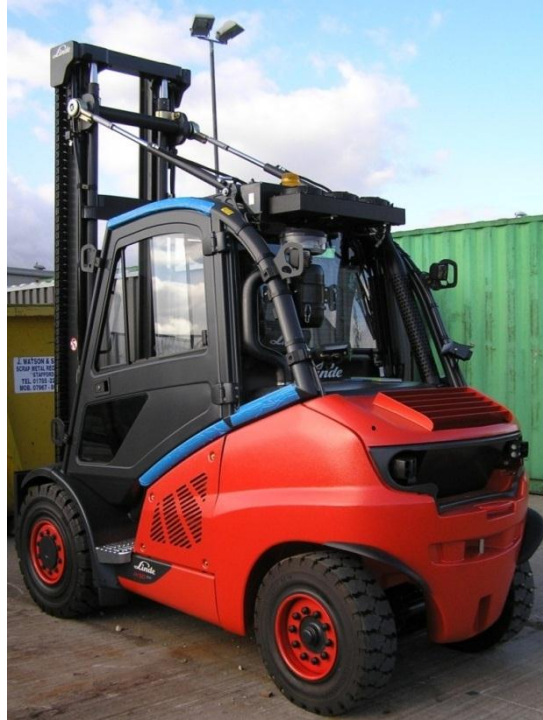
The TBM Hightech Control system was tested as fitted to a 5 tonne Linde 50D FLT (Figure 2). The 50D model was chosen as it is a similar size to the CAT-40, and therefore offers some degree of comparison⁶ between the systems tested on the CAT-40, and the TBM system tested on the Linde 50D.

Figure 2 Linde 50D test vehicle

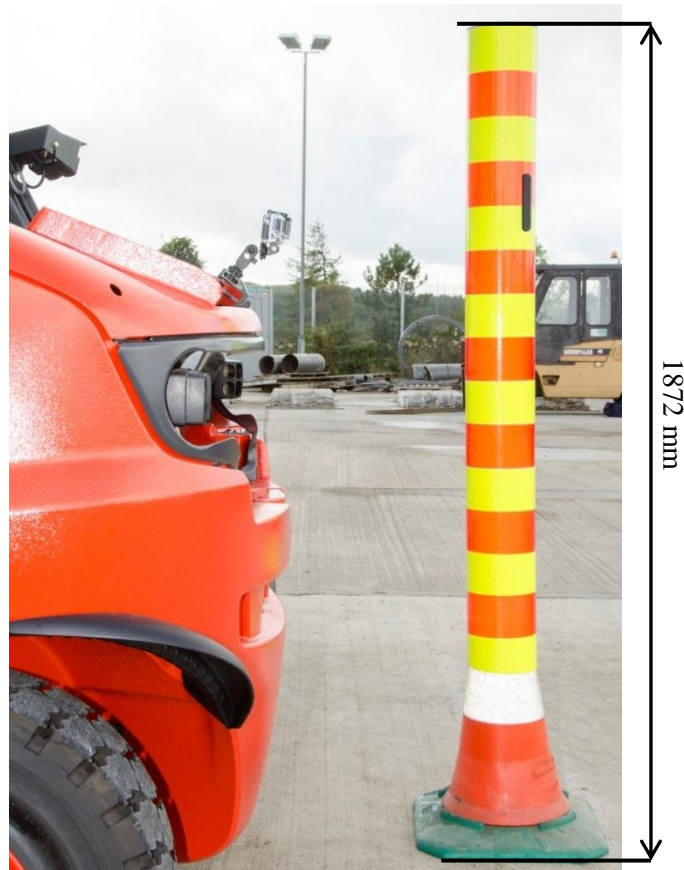
Figure 3 Test object used during the dynamic tests

For the dynamic test the test pole was located on the FLT centreline, 6 m from the rear fascia of the FLT. Markers were placed on the ground at 0.5 m intervals between the FLT and the test pole.

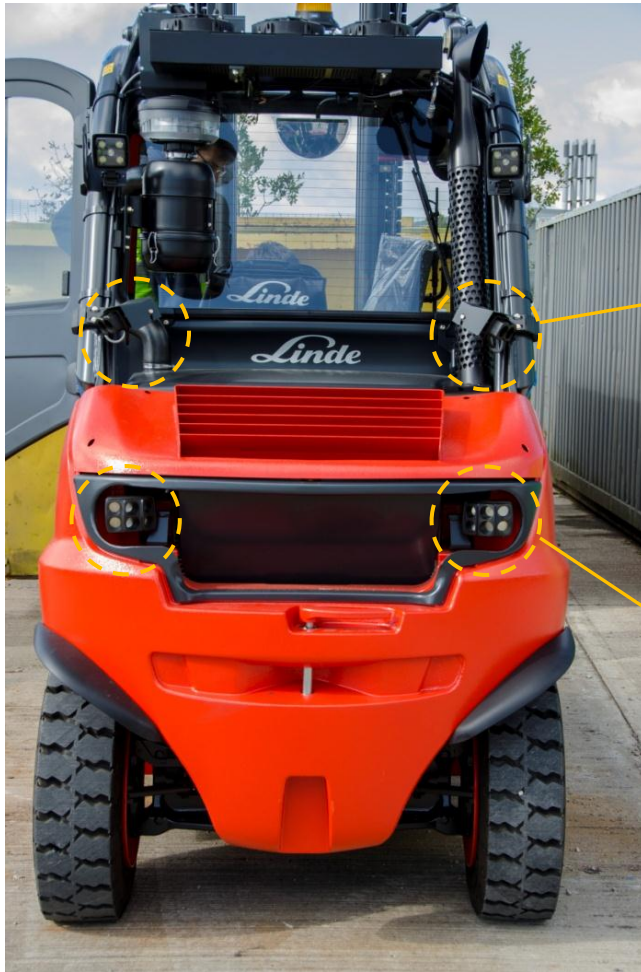
Figure 4a

Both side pods consisted of two sensors that were angled downwards.

Figure 4 Rear of the Linde truck showing the mounting position of the ultrasonic sensors

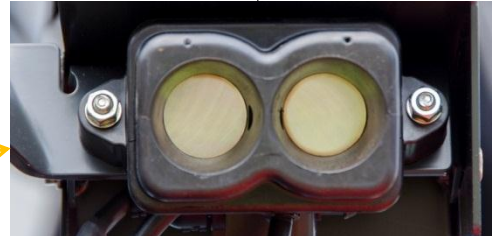
Figure 4b

The two rear pods consisted of six sensors, which were angled inwards towards the centreline of the FLT.

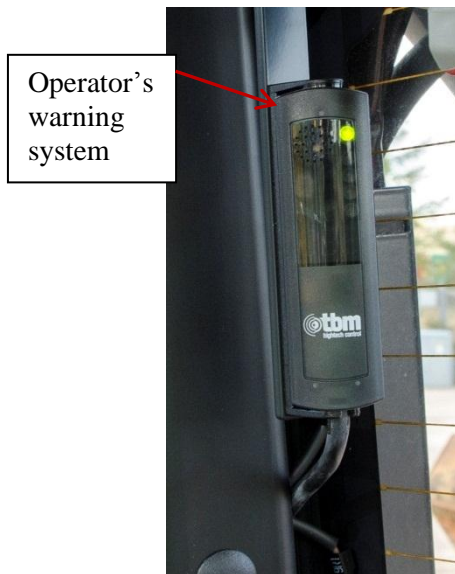
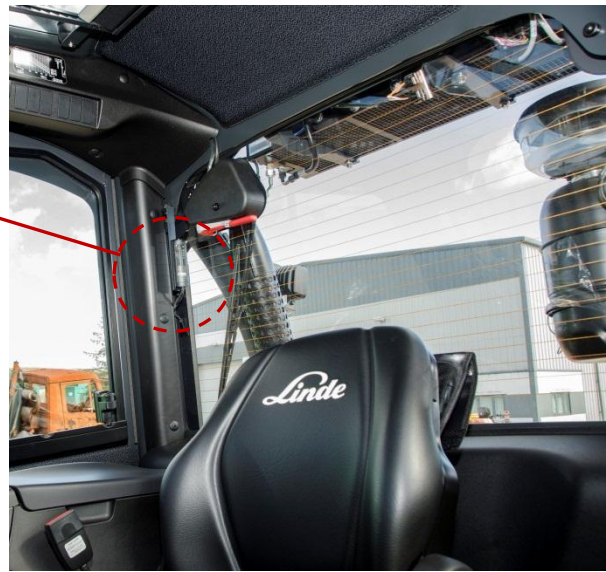
The operator's warning system consisted of an audible buzzer and a set of five LED lights (1 green, 2 amber, and 3 red). The warning system was positioned behind the FLT operator's right shoulder (Figure 5), meaning that when the operator was turned for reversing, the warning system would be within their field of vision.

Operator's
warning
system

Figure 5 Position of the warning system within the FLT cab

Upon inspecting the FLT cab it was noted that there were no warning override, or volume adjustment controls to allow the operator to adjust the warning system.

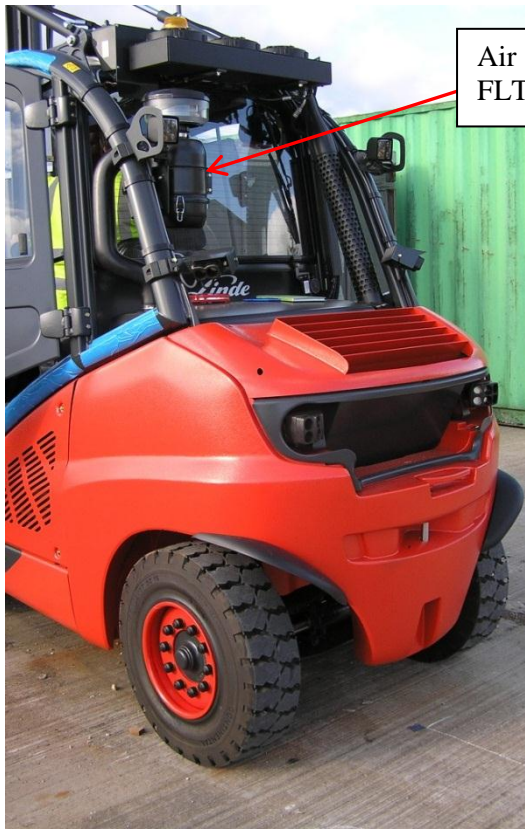
Figure 6a

Air intake canister obscured the view the FLT operator had of the LHS of the vehicle.

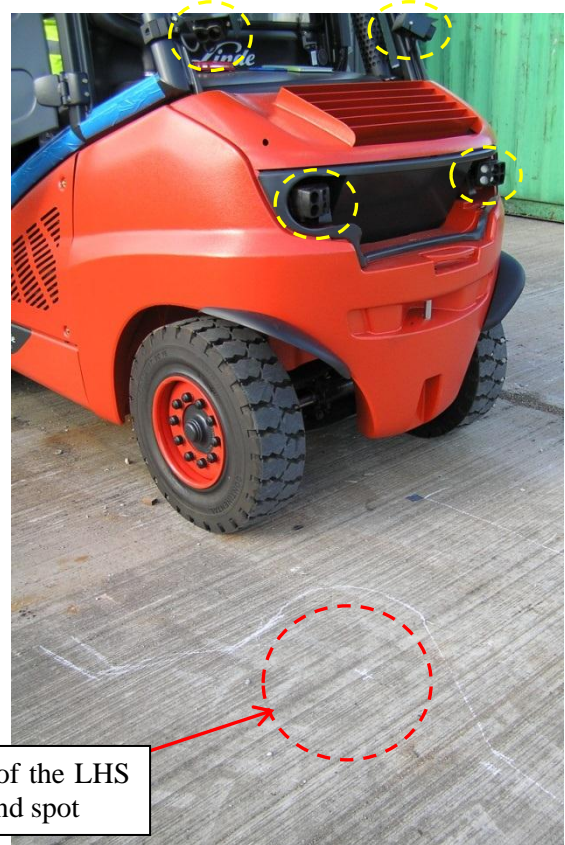
Figure 6b

The detection area narrowed considerably around the rear quarters of the FLT counterweight, with an area large enough for the test person to stand and not be detected, being formed in the area between the rear and side sensor pods (Figure 6b).

Location of the LHS sensor blind spot

The static test revealed that the positioning of the ultrasonic sensor pods created two blind spots either side of the FLT counterweight. The blind spots were large enough for the test person to stand and not be detected. The blind spot on the left hand side also corresponded with a visual blind spot caused by the air intake canister. As the test person had to approach the FLT from a specific angle in order to remain undetected, however, it is uncertain how significant these blind spots would be in practice.

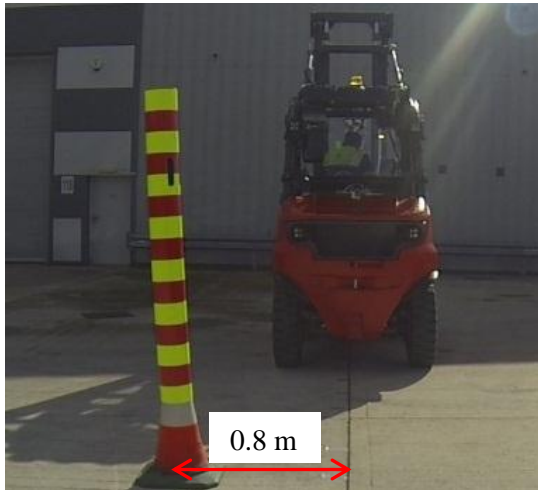
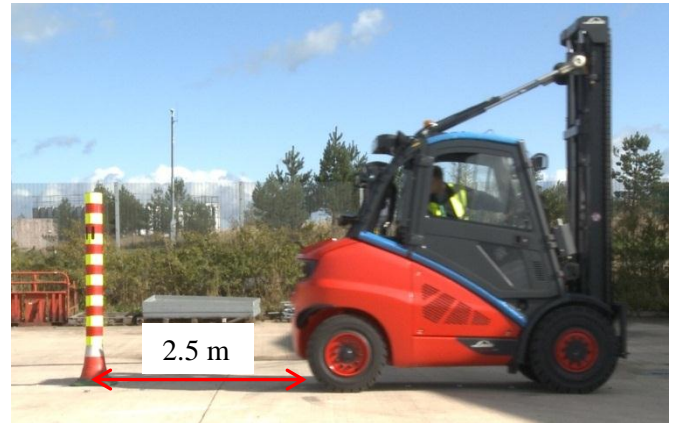
When the test pole was positioned 0.8 m to the side of the FLT centreline (0.1 m outside the width of the FLT), it was found that the speed reduction system activated at a distance of approximately 2.5 m from the test pole (see Figure 7).

Figure 7 Test pole positioned 0.8 m to the side of the FLT centreline

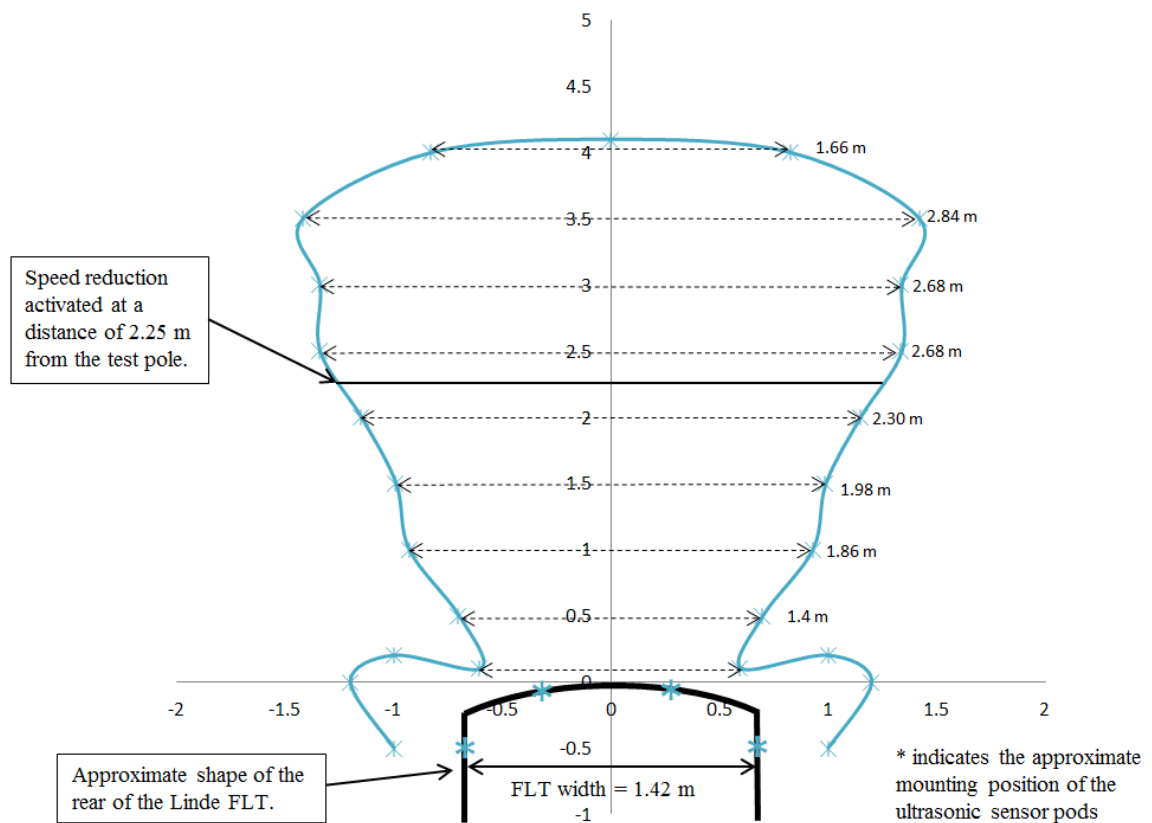
When the test pole was positioned 1.5 and 2 m from the FLT centreline, neither the speed reduction system, nor the operator's warning system was activated. This correlated with the 'map' of the detection area (Figure 8) obtained from static detection test.

Figure 8 shows that the visual and audible warning system would not be activated if an object was located further than approximately 1.4 m to the side of the FLT centreline, and the speed reduction system would not be activated if an object was located further than approximately 1.1 m to the side of the FLT centreline.

Figure 8 Diagram showing the approximate size of the TBM system's detection area

The maximum width of the detection area was found to be approximately 2.8 m, and was located 3.5 m from the rear fascia of the FLT. The maximum distance from the FLT that the test person could be detected was approximately 4 m, with a detection width of approximately 1.7 m at this distance. Due to the configuration of the sensors, there is a blind spot on both the right and left hand side of the FLT (Figure 6a). This was further compounded by the operator's warning system being located on the right hand side, which meant that the driver would have to turn to the right when reversing in order to view the warning system.

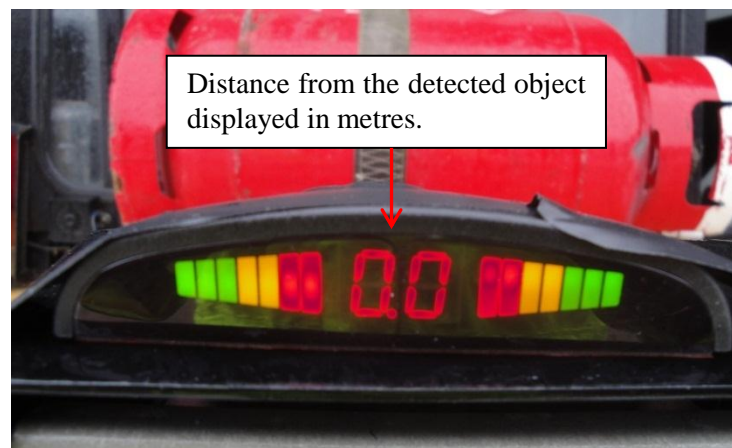
The operator's warning system consisted of two sets of seven LED warning lights, which represented either side of the FLT. By using two sets of lights, a visual indication as to which side of the FLT the object being detected was located, could be provided to the FLT operator. The change in colour (from green to amber, and then finally to red), and the increasing size of the LEDs, denoted the proximity of the detected object to the sensors. An approximation (in metres) of how close the object being detected was to the FLT was also provided in the centre of the warning system display (see Figure 9). The operator's warning system was fitted with a built in audible warning that increased in repetition rate depending on how close the object was to the sensors. There were no controls available to adjust the volume of the audible warning.

Figure 9 Backscan – operator's warning system

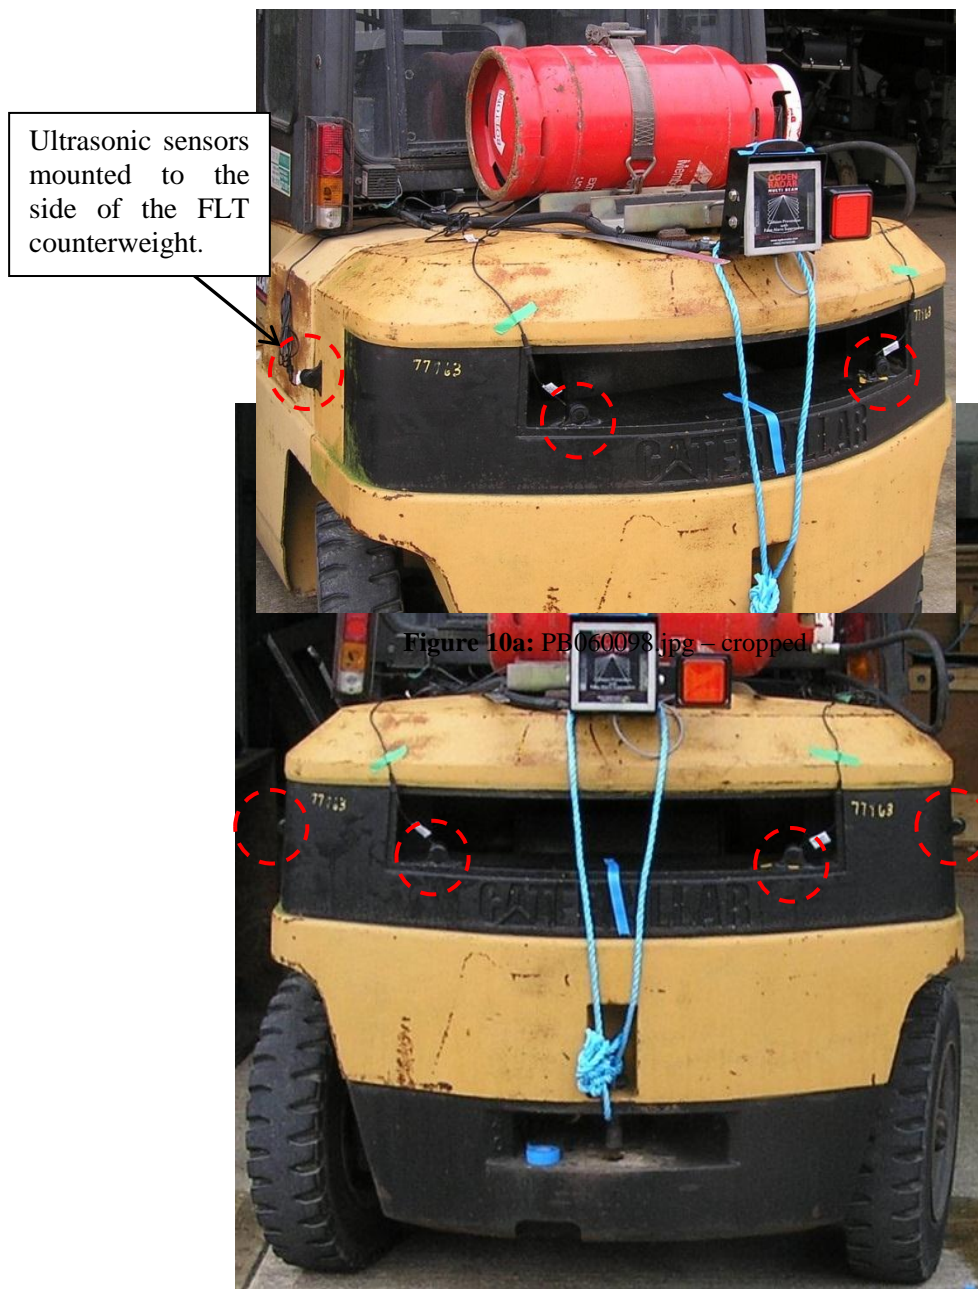
The ultrasonic sensors were attached to the FLT's rear counterweight, using the plastic brackets supplied with the detection system. The sensors were attached to the counterweight temporarily using Loctite adhesive. If the sensors were to have been mounted permanently to the FLT, then it was possible for the brackets and cables to have been attached to the counterweight using appropriate fasteners.

The sensors were mounted at a height of approximately 1 m from the ground, as recommended in the manufacturer's installation guidance. Two of the four sensors were positioned in the ventilation gap in the rear of the FLT counterweight. The other two sensors were mounted to the sides of the counterweight (Figure 10). The sensors were mounted symmetrically, to ensure the detection area had an even shape.

Figure 10 Mounting position for the ultrasonic sensors on the FLT counterweight

In order for the system to be mounted onto the FLT at the height recommended in the manufacturer's installation guidance, two of the sensors had to be mounted onto the side of the FLT counterweight. A potential problem with using this mounting configuration is that the sensors are exposed to environmental conditions such as mud and dirt, and the potential for impact damage to them is increased.

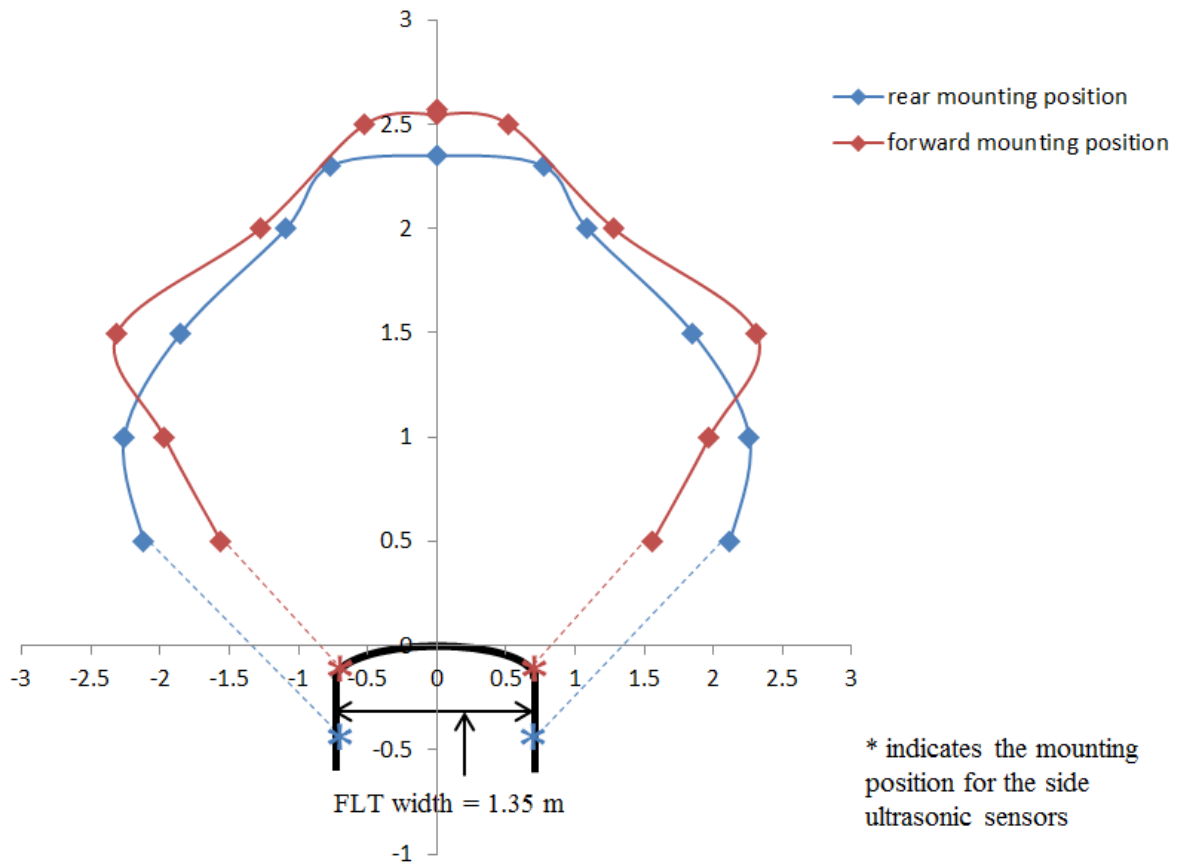
As can be seen in Figure 11, with the side sensors mounted further back (in the position shown in Figure 10b), the widest part of the detection area was positioned closer to the rear of the FLT. The rear mounting position was initially wider than the forward mounting position but after approximately 1.2 m became slightly narrower. The rear mounting position also had a slightly shorter maximum detection distance of 2.3 m, compared to the forward mounting positions maximum detection distance of 2.6 m.

Figure 11 Plot of the Backscan detection area - comparing the forward and rear mounting positions for the side sensors

As counterweight FLT's have a particularly tight turning circle, with the counterweight usually overhanging the rear (steering) axle, the rear has a tendency to swing rapidly round when manoeuvring. Increasing the width of the detection area closer to the rear of the FLT would therefore be the preferential option over increased detection width further away.

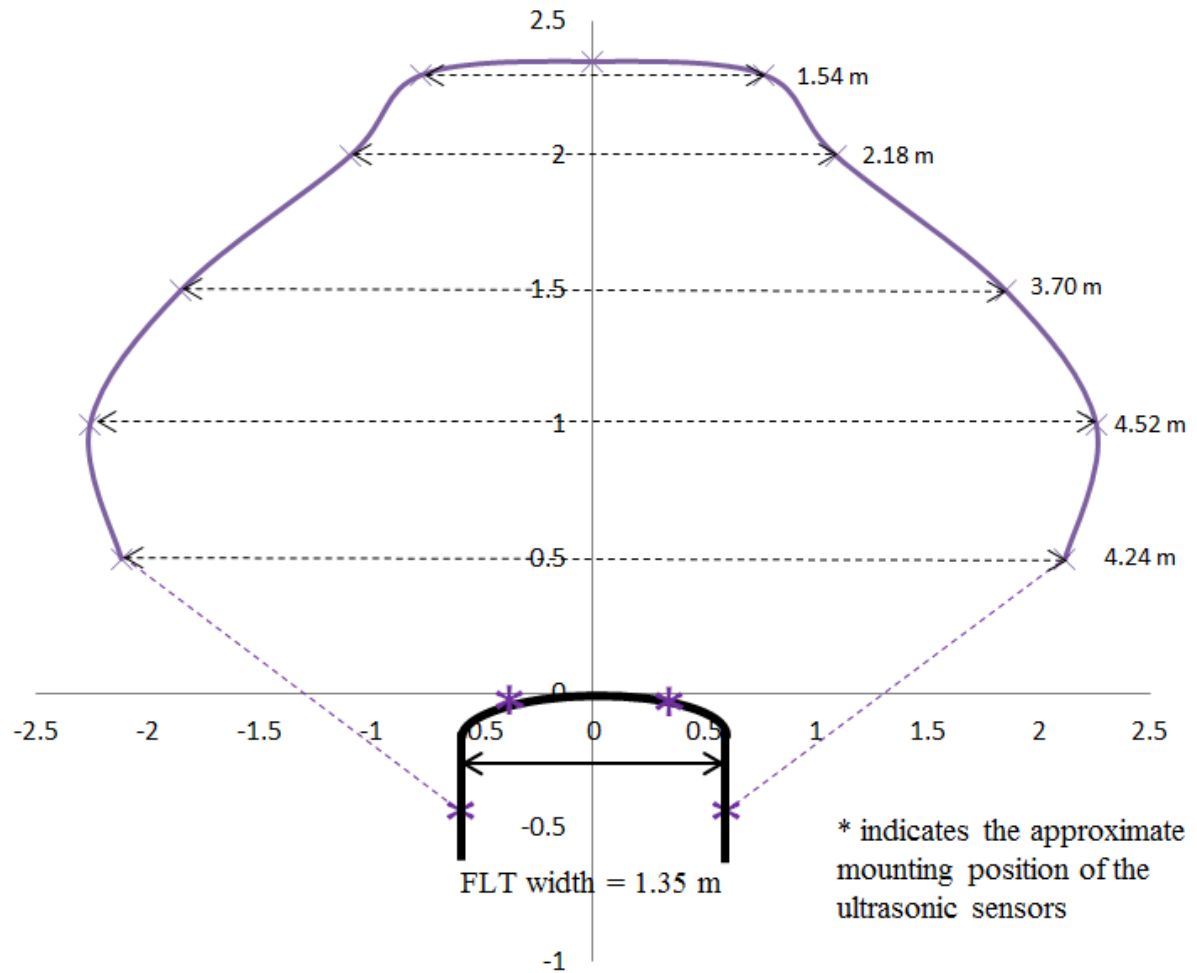
Figure 12 and Table 9 provide detailed measurements for the size of the detection area when the side sensors were mounted further back on the counterweight.

Figure 12 Diagram showing the plot of the detection area when the side sensors are positioned further back on the FLT counterweight

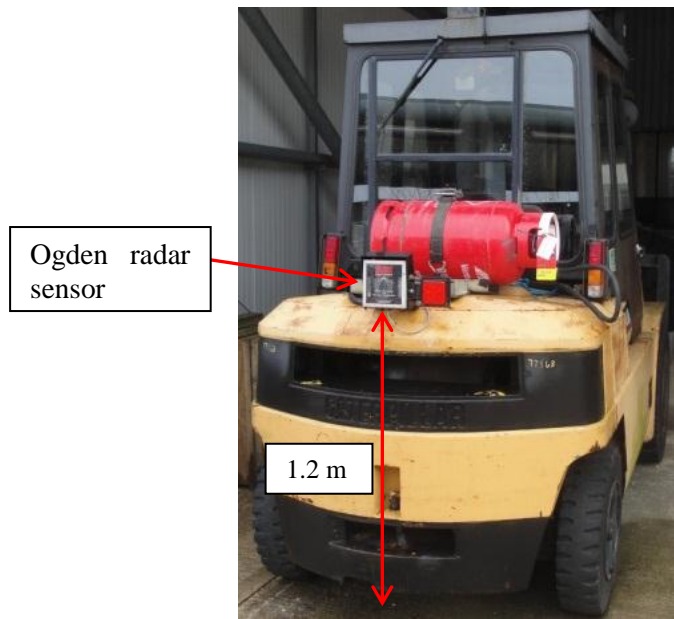
The Ogden radar sensor was mounted on the edge of the FLT counterweight at a height of approximately 1.2 m (Figure 13).

Figure 13 Installation of the Ogden radar sensor

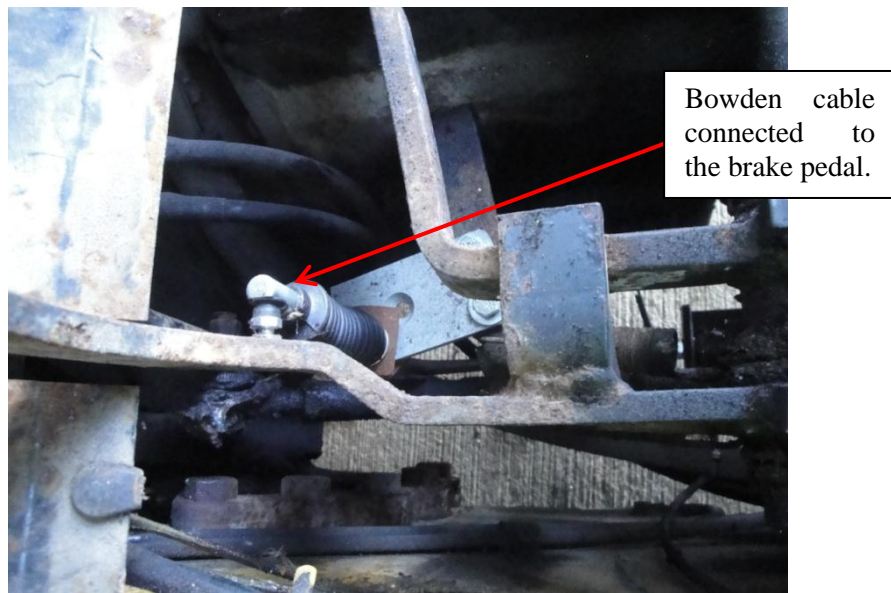
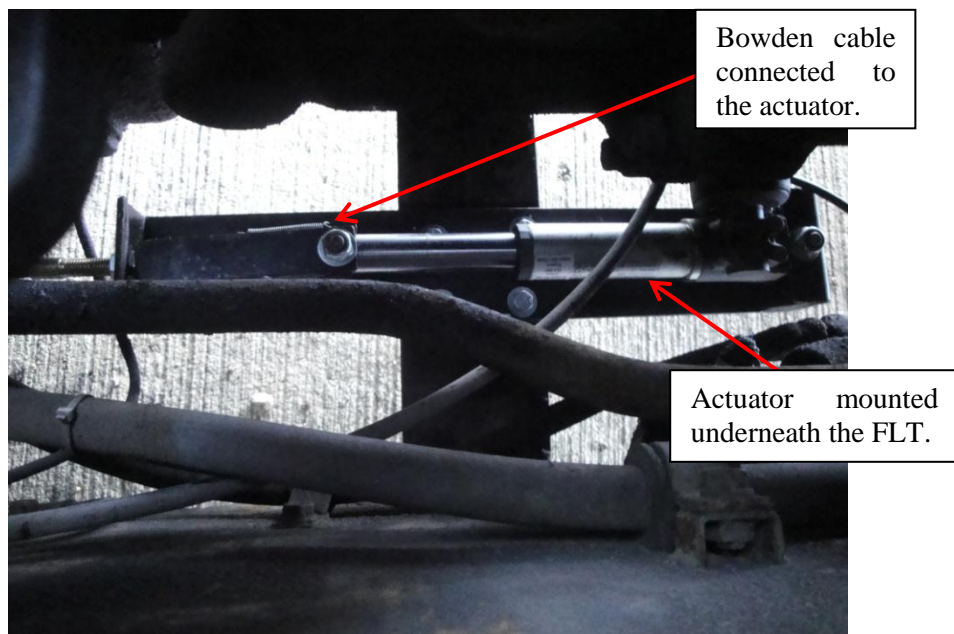
As can be seen in Figure 14, the active braking system consisted of a Bowden cable that joined the brake pedal (Figure 14a), to an actuator mounted on a chassis cross-member underneath the FLT (Figure 14b). When the system was activated, the actuator pulled on the Bowden cable which in turn depressed the brake pedal bringing the FLT to a halt.

Figure 14 Installation of the active braking component on the FLT

Once the active braking component had stopped the FLT, the operator was required to press an over-ride button located next to the seat in order to reset the actuator and release the brakes.

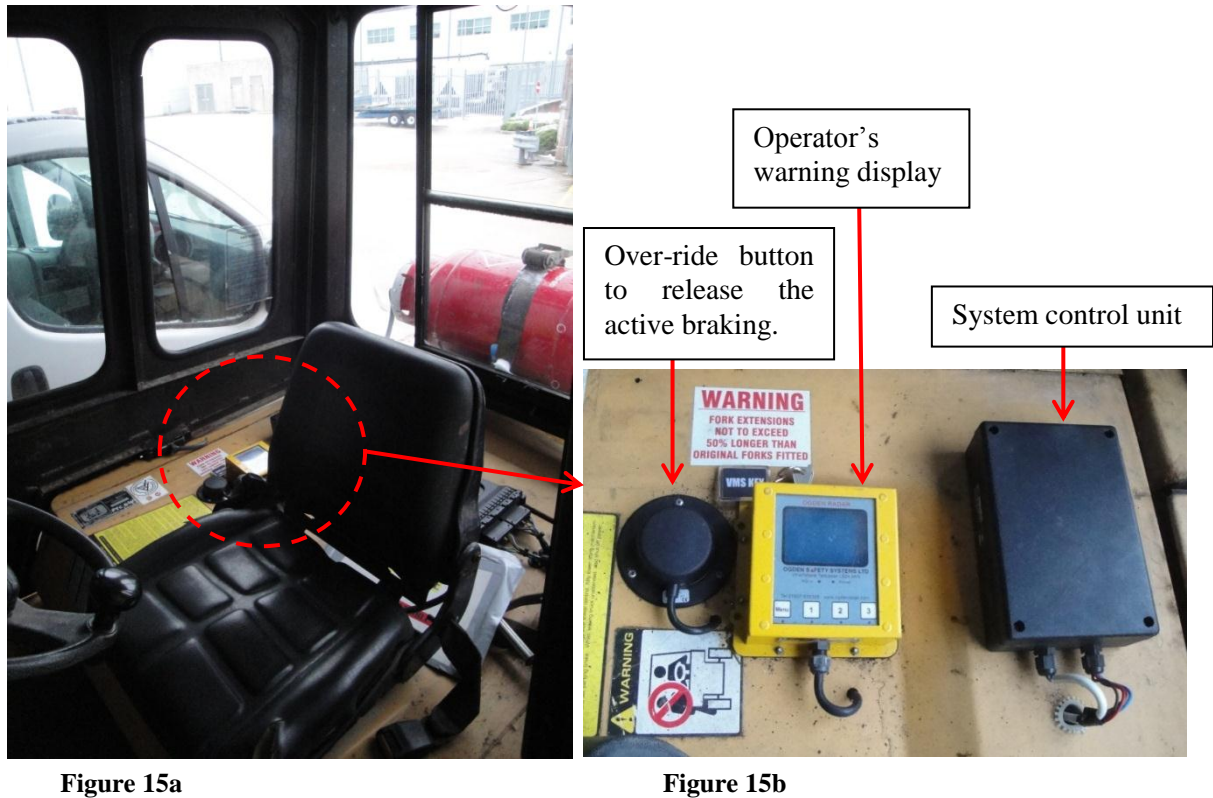
As can be seen in Figure 15, the warning display (yellow box) was mounted next to the operator's seat. The selected detection area could be changed from the display box. If the active braking component was not required, it could be turned off using the supplied key.

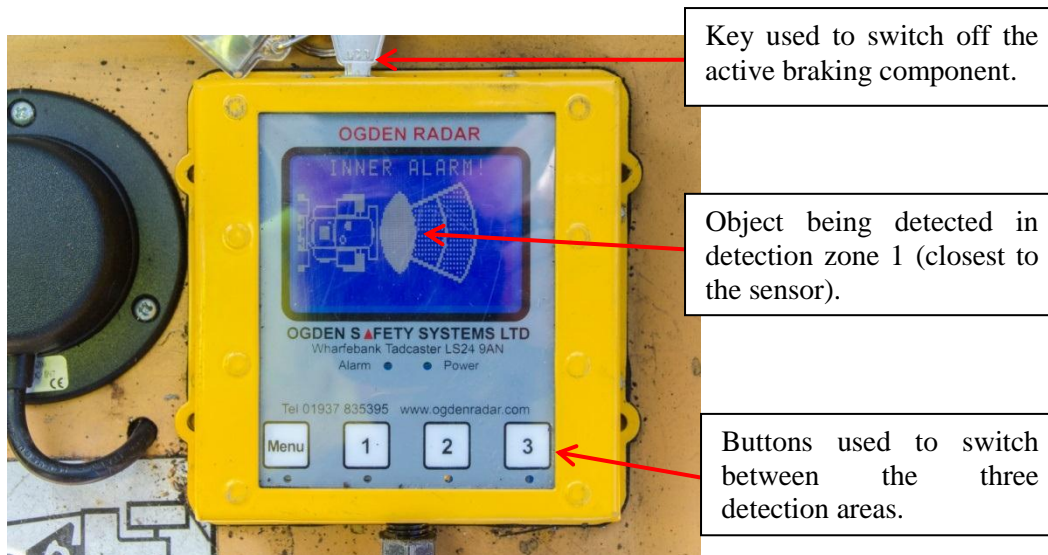
The warning system consisted of an LED screen which showed diagrammatically the shape of the detection area selected, and in which of the three detection zones an object had been detected (Figure 16).

Figure 16 Operator's warning display, indicating that an object has been detected in detection zone 1

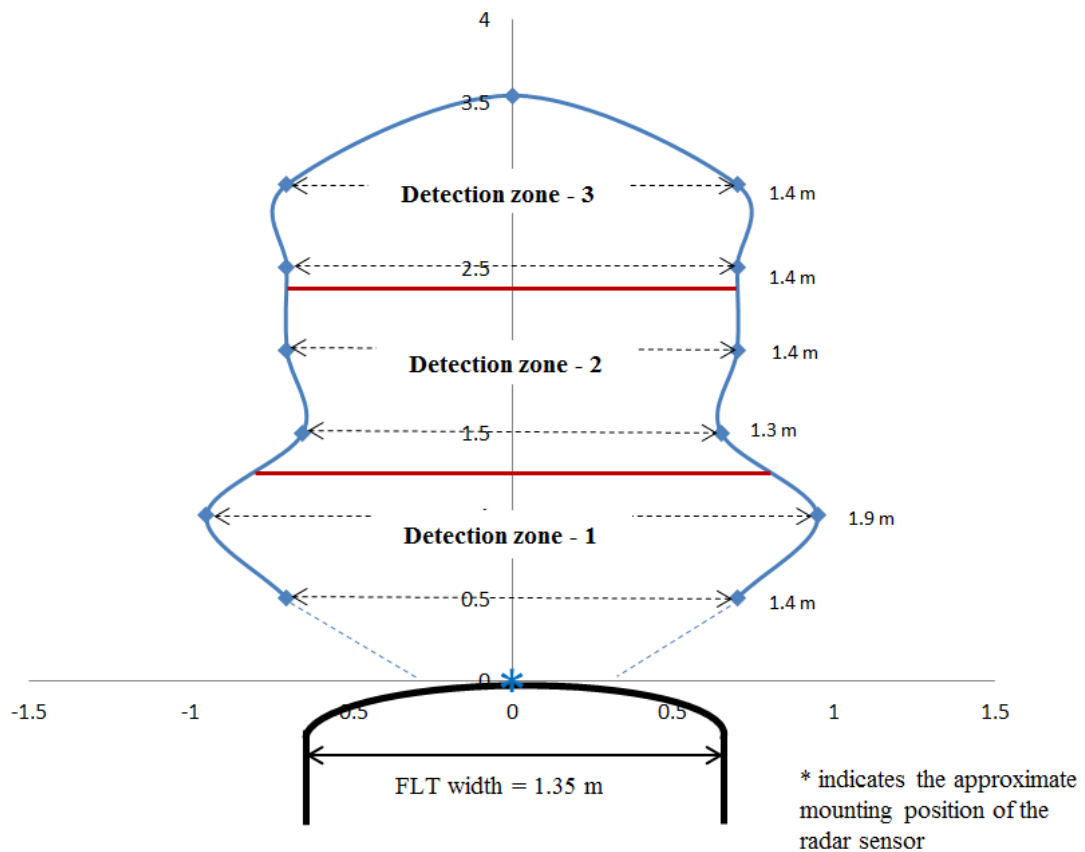
Figure 17 Plot of the detection area for the VMS system – setting one

<i>Centreline distance from the rear of the FLT (m)</i>	<i>Approximate width of the detection area (m)</i>
0.5	1.4
1	1.9
1.5	1.3
2	1.4
2.5	1.4
3	1.4
3.5	----

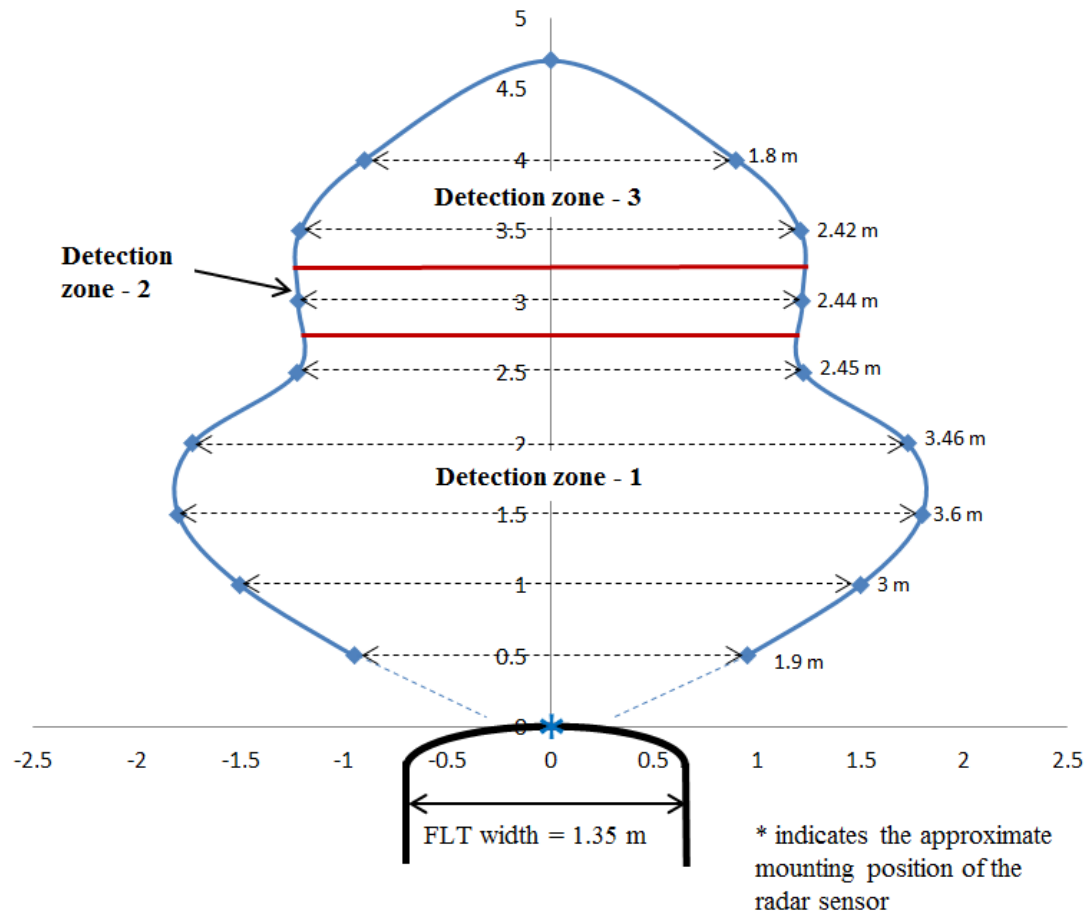
Figure 18 Plot of the detection area for VMS system - setting two

<i>Centreline distance from the rear of the FLT (m)</i>	<i>Approximate width of the detection area (m)</i>
0.5	1.9 m
1	3 m
1.5	3.6 m
2	3.46 m
2.5	2.45 m
3	2.44 m
3.5	2.42 m
4	1.8 m
4.7	-----

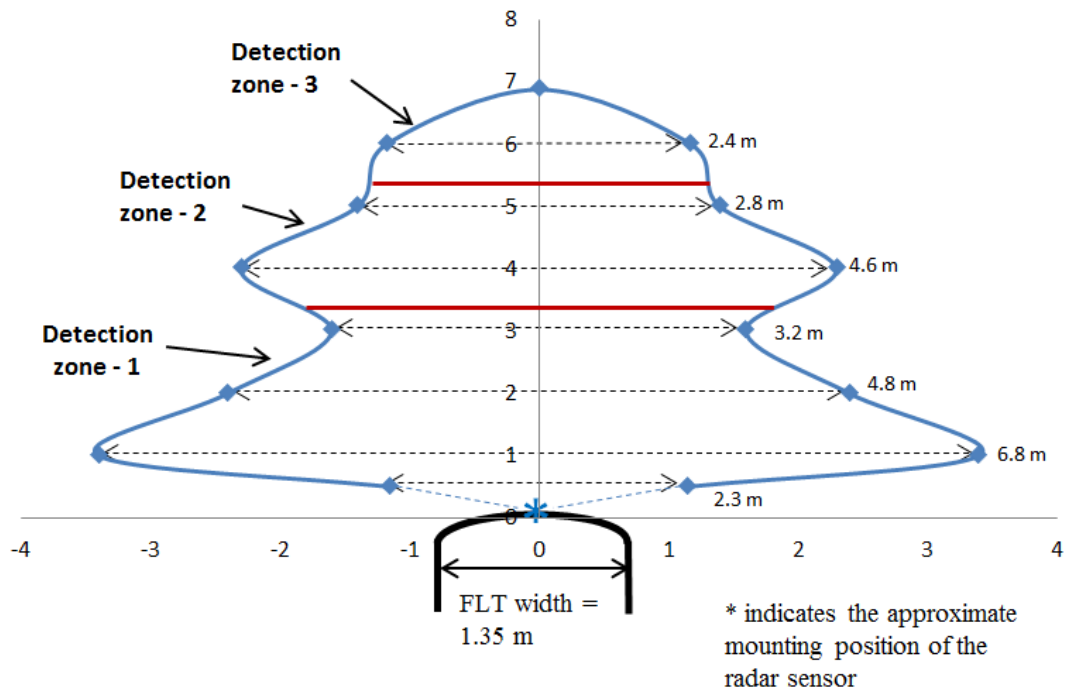
The third detection area was by far the largest (Figure 19), and had been designed to be used in large open environments such as those found in quarries. The size of the three detection zones within area three varied significantly, with detection zone 1 being the largest. The maximum width of the detection zone was approximately 6.8 m which exceeded the width of the FLT by approximately 2.7 m (either side). The maximum width of the detection area was located approximately 1 m from the sensor.

Figure 19 Plot of the detection area for VMS system - setting three

In the majority of operating environments it would most likely not be practical to use such a large detection area on a vehicle as narrow as the CAT-40 FLT. However, the size of detection area three does demonstrate the flexibility available between the detection areas.

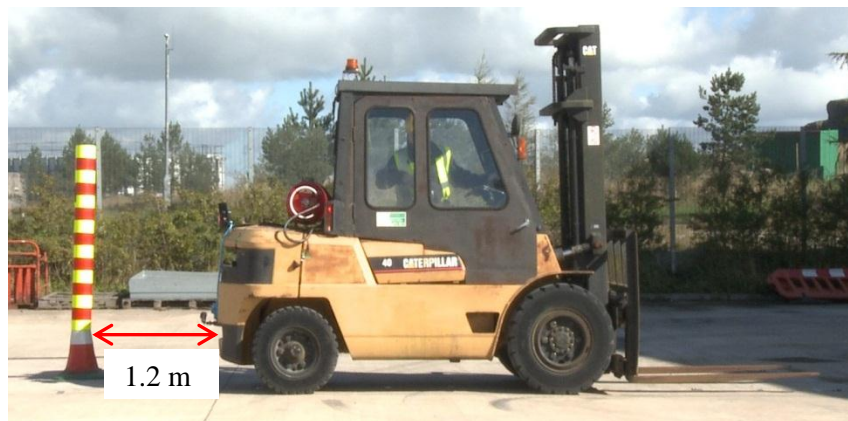
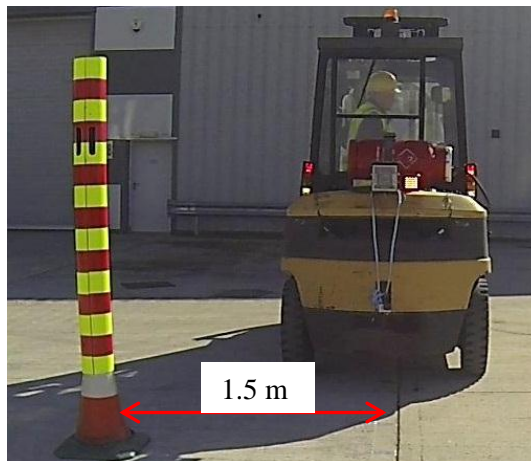
The automatic braking system was considered to be working effectively, as the FLT stopped within 1.2 metres of the test pole.

Figure 20 VMS system - dynamic testing

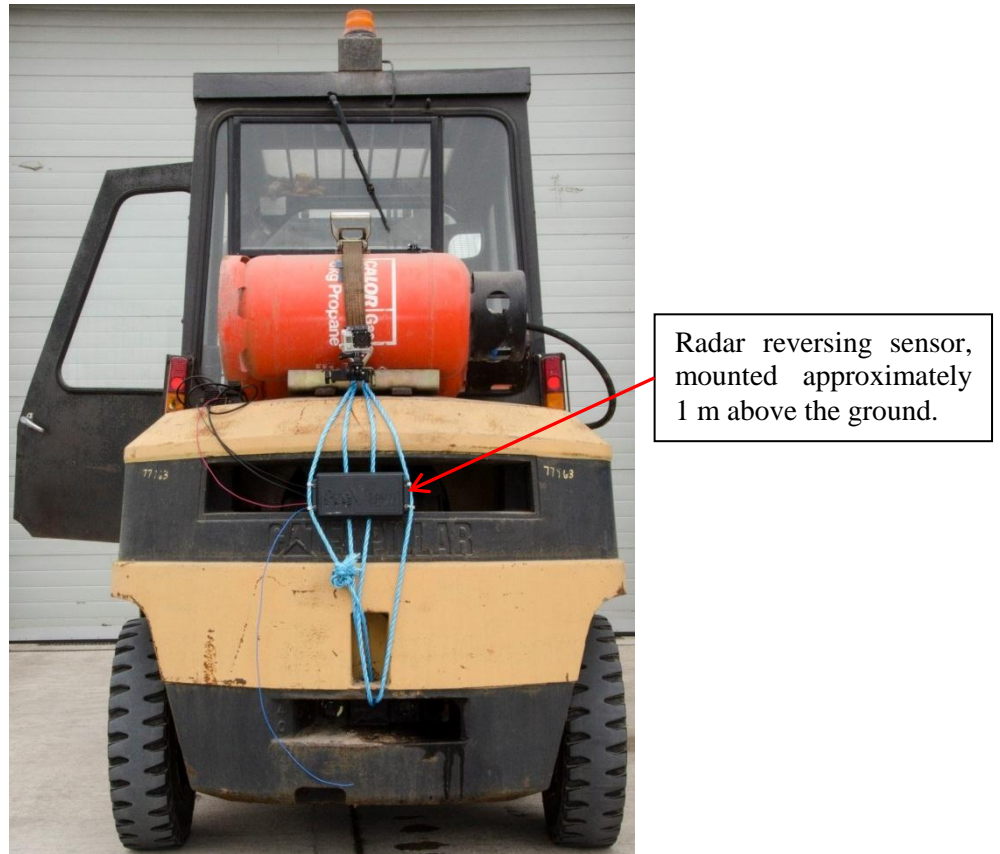
The sensor was mounted centrally on the FLT counterweight, approximately 1 m from the ground (as recommended in the manufacturers installation guide). The sensor unit was attached temporarily to the FLT using zip-ties and nylon rope (Figure 21), which allowed for adjustment of the sensor height during testing (if required).

Figure 21 Rear of the CAT – 40 FLT, with the radar sensor mounted centrally

A bracket could be fabricated allowing for the sensor to be mounted over the counterweight's ventilation gap if the sensor was to be attached permanently to the FLT.

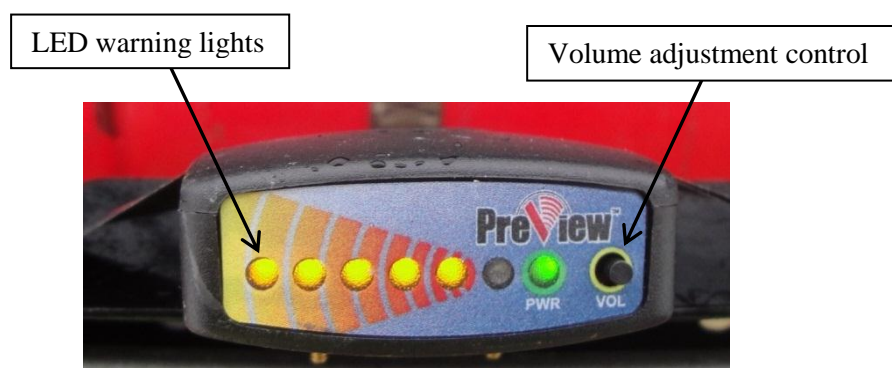
The operator's warning system consisted of a set of five LED warning lights (Figure 22), with an audible warning system also incorporated into the unit. The number of LEDs that were activated, and the repetition rate of the audible warning, increased the nearer an object came to the sensor unit. The volume of the audible warning could be adjusted by the FLT operator, with three distinct volume levels to choose from.

Figure 22 Backsense - operator warning system

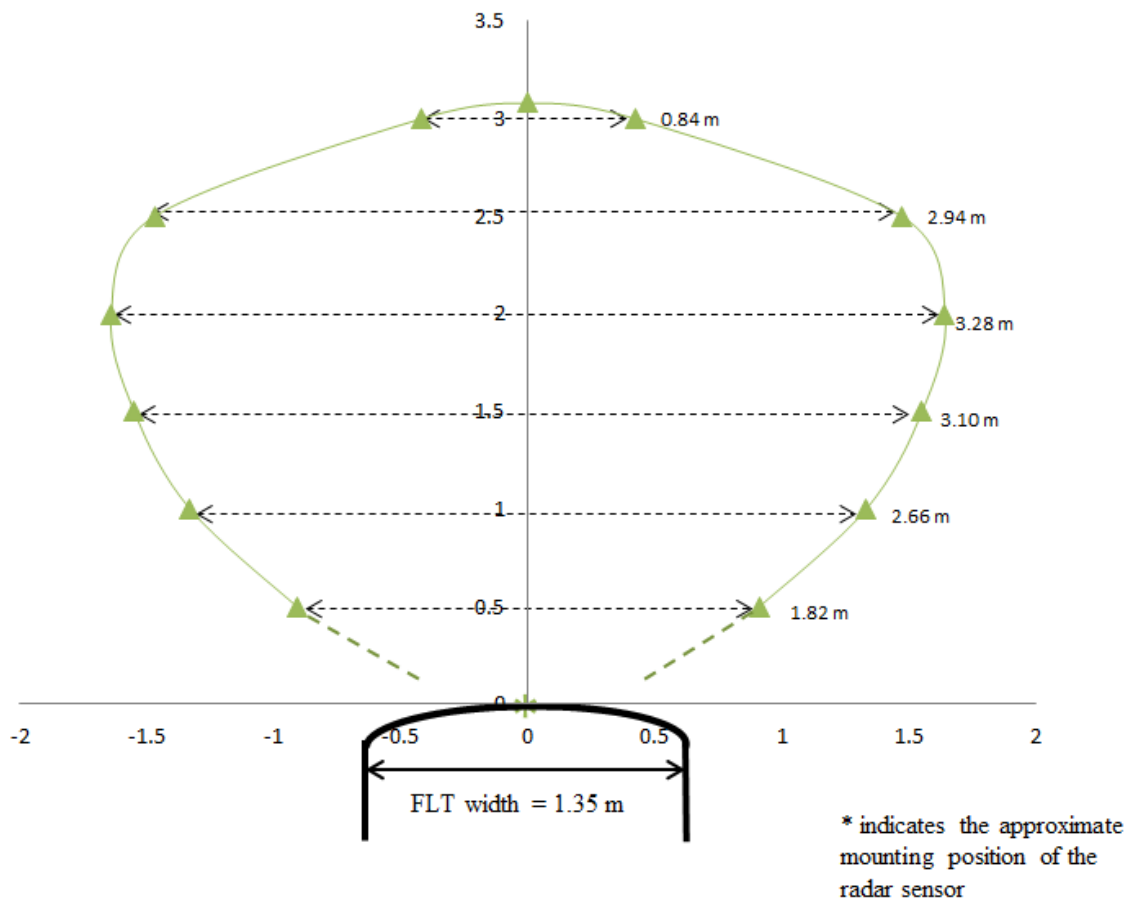
The Backsense system had a maximum detection width of approximately 3.3 m, located approximately 2 m from the sensor. The maximum width of the detection area exceeded the width of the FLT by approximately 0.8 m on either side of the FLT. The maximum distance that the system could detect the test person was approximately 3 m.

As can be seen in Figure 23 the detection area was cone shaped, which left two areas close to the FLT either side of the sensor where there would be no detection coverage as indicated by the dotted green line.

Figure 23 Plot of the detection area for the Backsense radar system
